ISO/TC 172/SC 7/WG 2
Spectacle frames

N 0243

Fading of logos – 12870 perspiration test.

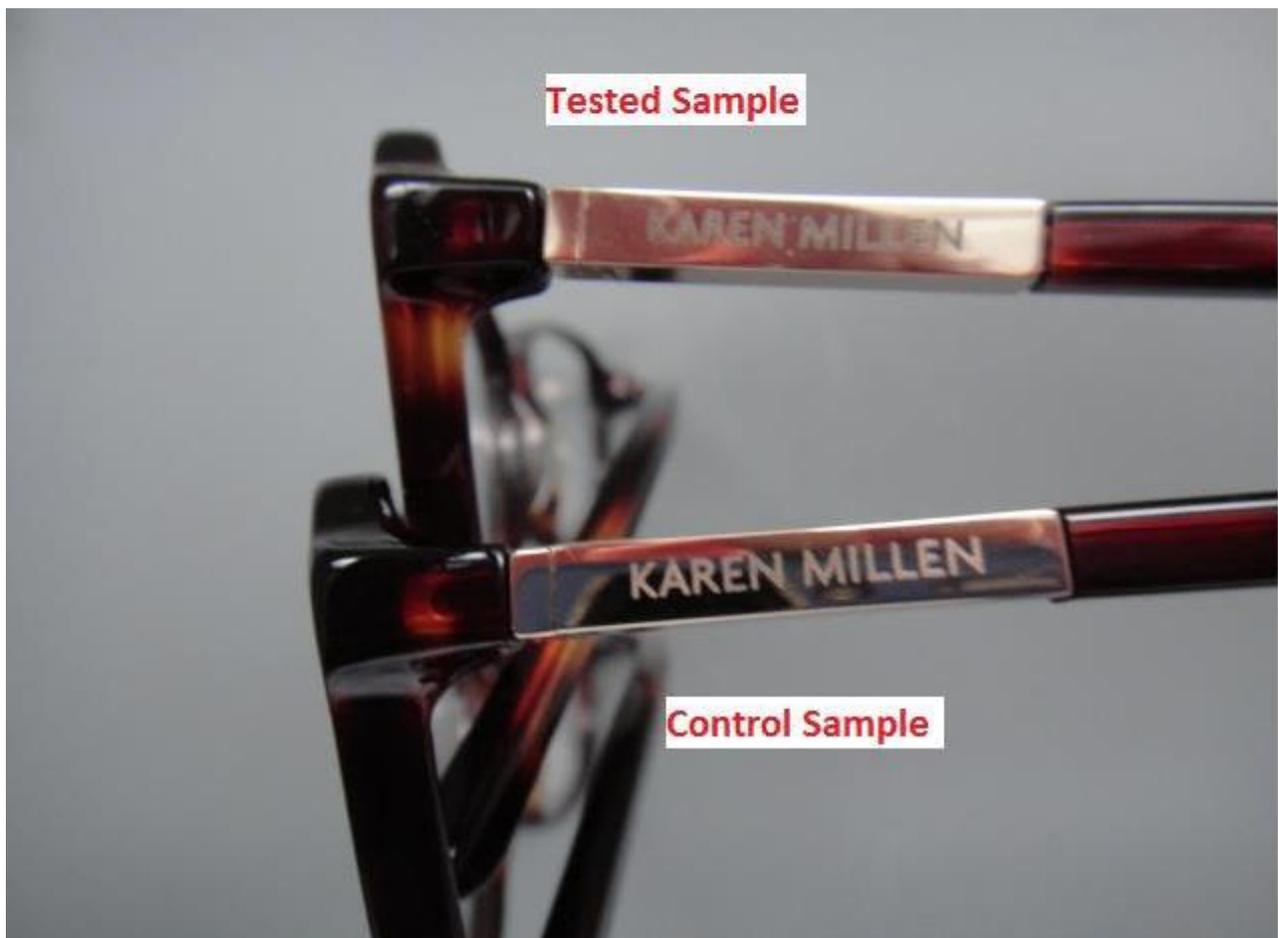
I have had two recent queries on the fading of logos during the perspiration test. **The first query related to fading of logos in the 8 hour test:**

When the spectacle frame is tested in accordance with 8.3, there shall be
a) no spotting or colour change (except for loss of gloss on surface) anywhere on the frame, excluding joints and screws, after testing for 8 h

I am not sure how important it is for such printing not to fade. When writing the first edition of ISO 12870, we certainly did not want frames to change colour, e.g. a blue frame to end up green!
